NAVAL AIR ENGINEERING CENTER

REPORT NAEC-92-162

HYDRAULIC SYSTEM WEAR DEBRIS ANALYSIS

Final Report for Period September 1980 to September 1981
A03V3400/051B/1F41-461-000

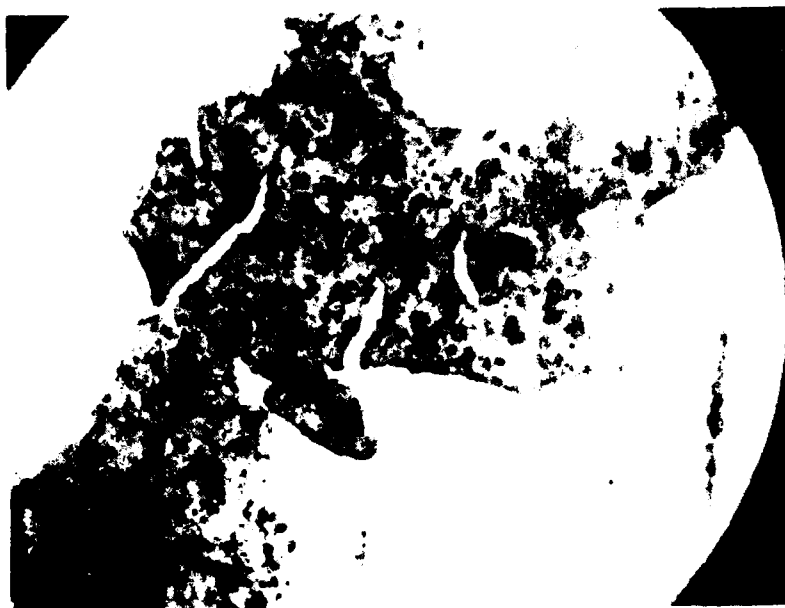
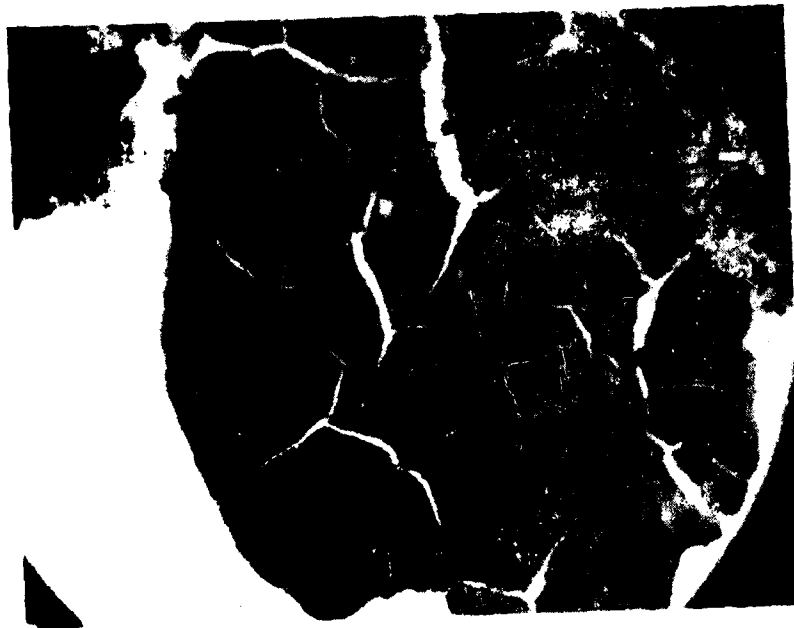
Figure 11 - Photographs of Film Transfer Wear
Particles at 40X (Sheet 1 of 2)

d. Film transfer wear is illustrated in Figure 11 which presents photographs at 40X magnification of extremely thin "particles." A great

deal of background light appears through the elastomer wear. This debris is thought to be the result of the transfer of a thin polymer film from the seal to the shaft.

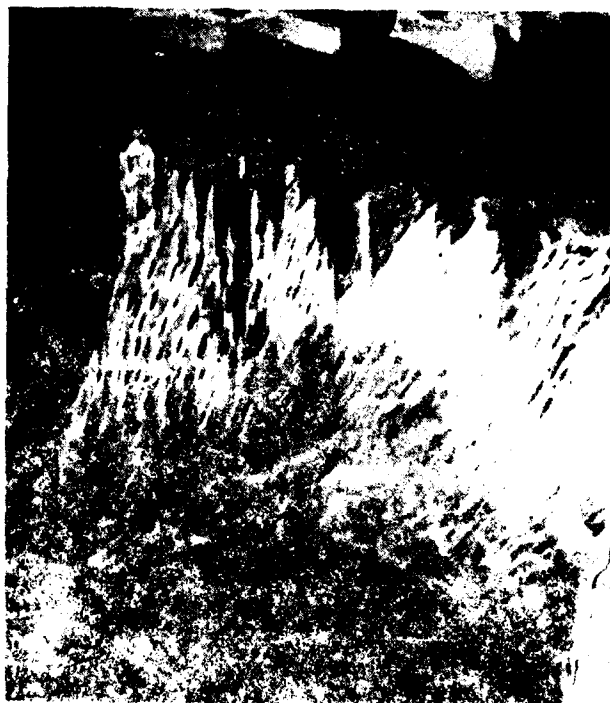
d. Figure 29A shows the counts for the fabric debris, which are shown at a magnification of 1100X in Figure 29B. No sulfur is observed.
